Manhole Inspection Summary

Manhole # S49EE_019MH

Insp Date: **7/13/08 10:52 AM**

Location Address: **milton st**

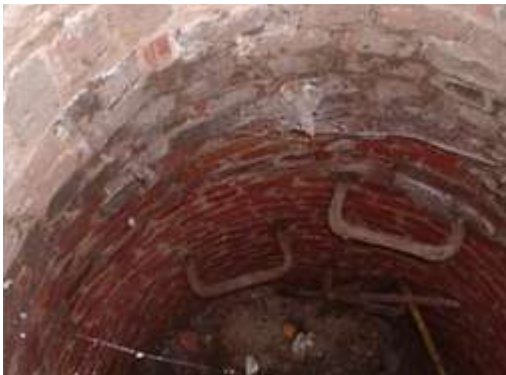
Defect 1

Infiltration: ☐ None ☒ **Joint** ☐ Cracks ☐ Mortar ☐ Roots ☒ **Wall**

infiltration

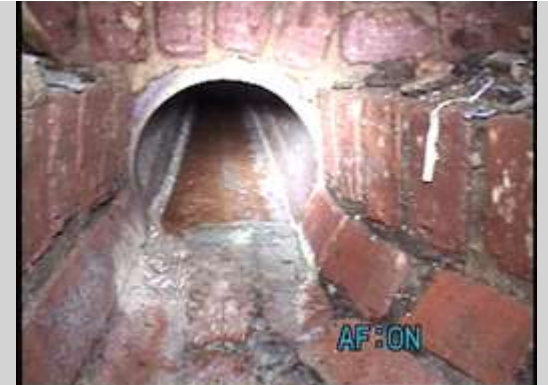
12 O'Clock Outflow

8 in. Circular Gravity Sewer
Pipe Out @ 12 O'Clock

Pipe Height: **8.4** (in.) Rod and Bar (Angled)
Pipe Material: **Clay** ☐ Pipe Lined
Invert Depth: **9.05** (ft.) Flow Characteristics: **Slow**
Deposits: ☒ None ☐ Mud ☐ Sludge ☐ Debris ☐ Grease
Silt Depth: (in.) Deposits Extent:
Infiltration: **None** Pipe Seal Cond: **Sound**

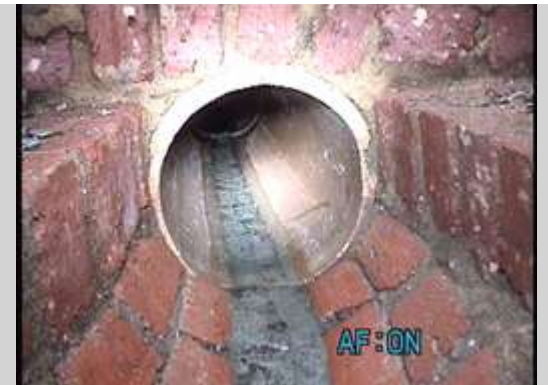
3 O'Clock Inflow

8 in. Circular Gravity Sewer
Pipe In @ 3 O'Clock

Pipe Height: **8.4** (in.) Rod and Bar (Angled)
Pipe Material: **Clay** ☐ Pipe Lined
Invert Depth: **8.90** (ft.) Flow Characteristics: **Slow**
Deposits: ☒ None ☐ Mud ☐ Sludge ☐ Debris ☐ Grease
Silt Depth: (in.) Deposits Extent:
Infiltration: **None** Pipe Seal Cond: **Sound**

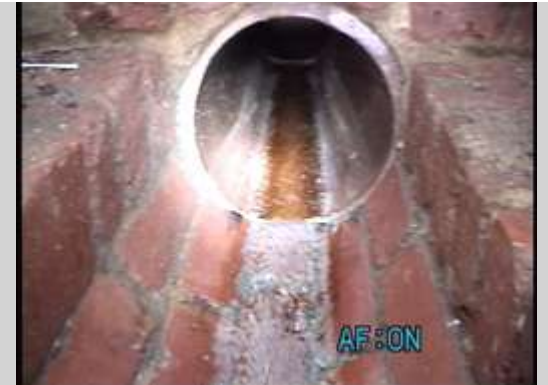
6 O'Clock Inflow

8 in. Circular Gravity Sewer

Pipe In @ 6 O'Clock

Pipe Height: **8.4** (in.) Rod and Bar (Angled)

Infiltration: **None** Pipe Seal Cond: **Sound**
